Evaluation of fracture strength of endodontically treated teeth restored by milled zirconia post and core with different post and core systems (An in vitro comparative study)

ABSTRACT

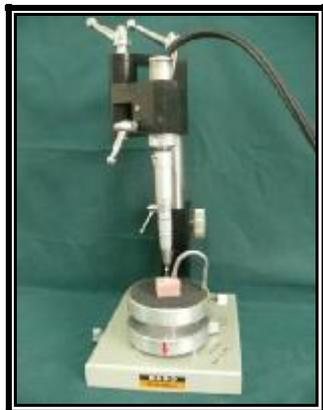
Figure 1: preparation of post space.

Post space preparation was done with a low – speed straight hand piece attached to a dental surveyor with standard diameter (rubber stopper was attached to the pessoreamer (size Nr- 4 Ø 1.50, Nordin, Switzerland) the depth was adjusted to 10mm Thus 4-5mm of Gutta- Percha kept apically^(7,8) as in figure(1). For all specimens in groups 1, 2 and 3 the post were tried in to verify their fitness.

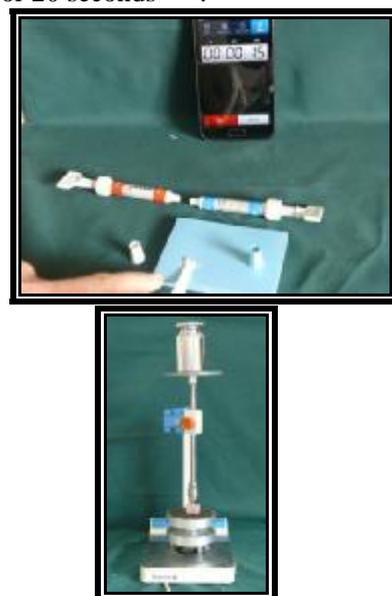
Figure 2: (a and b): cementation.

All post spaces were cleaned, dried and etched with 37% wt phosphoric acid gel (for 10seconds) then washed with distilled water⁽⁹⁾. ED PRIMER II (Kuraray, Japan) liquid A and B (as a bonding agent) mixed and applied; left for thirty (30 seconds), and air jet for ten seconds. Panavia F 2.0 dual-cure dental adhesive system (Kuraray, Japan) was used as cementing medium (figure 2a), while the post attached to the horizontal arm of the surveyor, the mixture was applied to the post surfaces. The post was then seated in to its respective space, using 2 kg constant load (figure 2b). Excessive material was removed by a micro brush within 40 seconds, and then light cured applied for 20 seconds^(7,8).

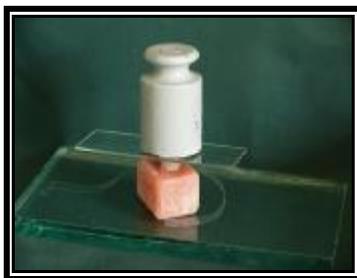
Figure 3: core built up

For groups 1, 2, and 3, the coronal portion of the posts (3mm) and the remaining tooth structure (2mm coronal to the CEJ) were cleaned from debris. A phosphoric acid 37%wt were applied to the area (for 15 seconds), after washing the acid bonding resin was applied using micro-brush and cured for 20 seconds. A plastic cylindrical matrix of 5 mm height and 6mm diameter used as a mold to build a standard core. After packing of composite in plastic matrix celluloid strip was placed over, one mm thickness glass slide was pressed under a load of 200gm for 1 minute⁽¹⁰⁾ (figure 3). The composite was light cured using a halogen light cure device for 40 second. After curing and removing the cylinder plastic matrix from the specimens, a further curing for 60 seconds, was carried out to all sides.⁽¹¹⁾

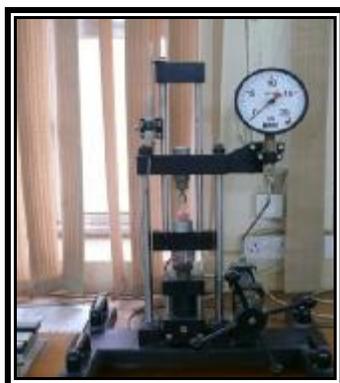
Figure 4: Testing procedure.

Testing procedure: The samples were placed on the flat table of the universal testing machine (WP 300) (Zwick, gunt, Humburg, Germany) (figure 4). A continuously increased compressive load was applied perpendicular on the flat occlusal surface of the core until failure. The load was measured in Newton (N). The mean failure load for each group was calculated.⁽¹³⁾

Attempts were made to simulate the force of the oral cavity on the roots on mandibular first premolars, while the teeth were oriented vertically in the alveolar bone ⁽¹⁴⁾. Occlusal surfaces of cores were prepared uniformly so that the forces can be applied at the long axis and at the middle of the teeth.

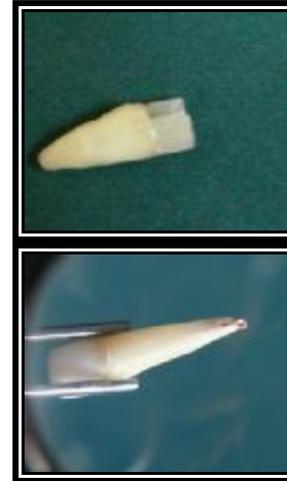
Figure 5: Failure location

After completion of testing procedures, all the specimens were examined using a magnifying lens to determine the root fracture patterns and

locations. The fracture patterns were divided into two groups⁽¹⁴⁾(figure 5):

- 1) Coronal fracture (desirable fracture).
- 2) Root fracture (undesirable fracture).

Group 1: Seven teeth were fractured at the coronal part (composite core) and one tooth was with catastrophic failure (root fracture at the apical part).

Group 2 and group 3: all the fractures were in the coronal part (composite cores). No root failures.

Group 4: one tooth was fractured at the coronal part. The rest seven teeth were fractured at the apical part.

Group 5: all teeth were fractured at the coronal parts.

When the fracture occurs, the pattern of fracture is important as it acts as guidance for the restorability of fractured teeth. In the present study, the fiber post treated teeth showed significantly more desirable fracture patterns compared to those restored with zircon posts. This result agrees with **Mortazaviet al**¹³. This result suggests that zirconium posts and cores can be used when esthetic demands are important and the anatomy of the root canal and/or the extensive loss of coronal tooth portion require the use of custom post. Single unit zirconium post and core may be indicated when ceramic crown is used.

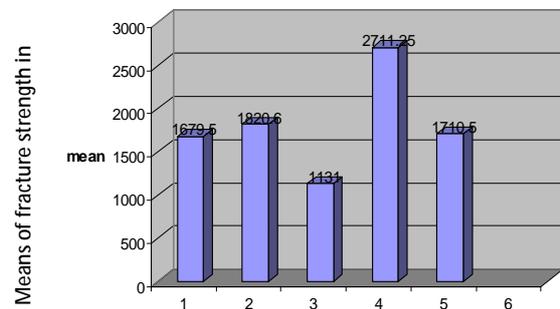
The means, standard deviations (S.D) of the fracture strength values with minimum and maximum values of each group were collected as in figure (6).

Figure 6: The bar charts showing means of fracture strength in N for all groups

One- way analysis of variance (ANOVA) was applied. The result was high significant difference among groups. Further analysis of the result using student's t- test was applied in order to localize the source of significance of the difference between groups. The results of T-test between the Groups can be summarized as following

Group 1: Shows non significant difference with group 2 and group 5 and significant difference with group 3. While high significant difference with group 4.

Group 2: Shows non significant difference with group 5 and shows high significance with group 3 and group 4.

Group 3: Shows significance difference with group5 and shows high significance difference with group4.

Group 4: Shows high significance difference with group5.
