Effect of dispensing method and curing modes on the microleakage of composite resins

Bahar Jaafar Selivany ⁽¹⁾, Muhand Abduljabar Khadim ⁽²⁾, Dara Hama Saeed ⁽³⁾,
Abdulhaq Abdulmajeed Suliman ⁽⁴⁾

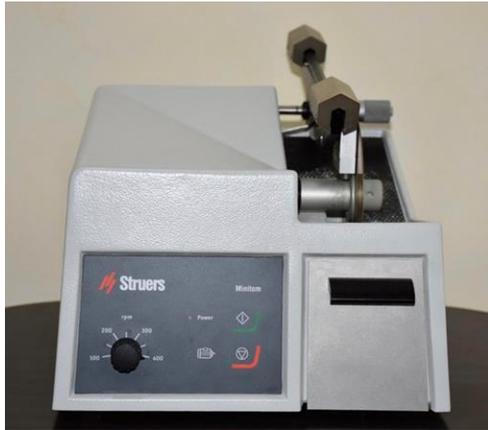
Figure 1: Minitome, Struers, Copenhagen, Denmark.

The teeth were longitudinally sectioned using microtome (Minitome, Struers, Copenhagen, Denmark) (Figure 1). For each tooth, there were two readings, one for each half (n=20). Dye penetration was assessed under a stereomicroscope (10X). Dye penetration was scored for both enamel and dentin margins on a scale from 0 to 4.⁽²⁶⁾
